Manhole Inspection Summary

Manhole # S35YY_034MH

Location Address: **330 33RD ST**

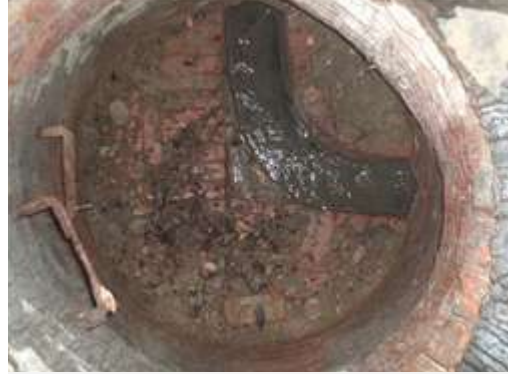
Top View

Corroded steps. Evidence of surcharge - Bench debris.

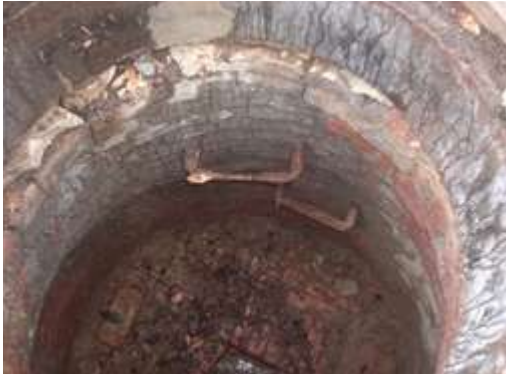
Defect

Frame offset. Adjustment deterioration and infiltration. Barrel infiltration - other side.

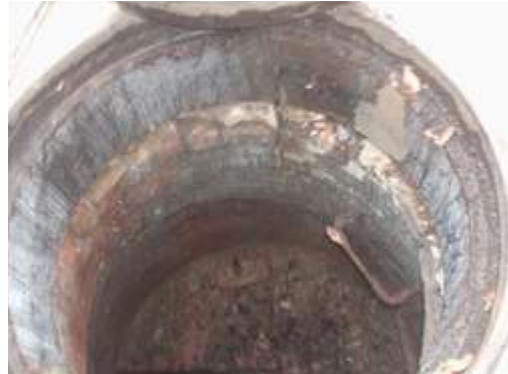
Defect

Frame offset. Adjustment deterioration and infiltration. Barrel infiltration.

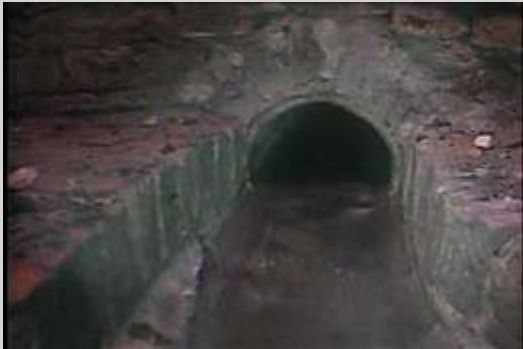
8 in. Circular Gravity Sewer Pipe Out @ 12 O'Clock

Infiltration: **Evidence** Pipe Seal Cond: **Unknown**

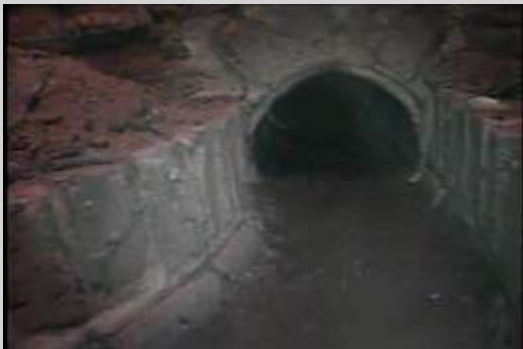
8 in. Circular Gravity Sewer Pipe In @ 3 O'Clock

Infiltration: **Evidence** Pipe Seal Cond: **Unknown**
